RICS Home Surveys

# **Survey level two: HomeBuyer report - Survey**

18<sup>th</sup> October 2018

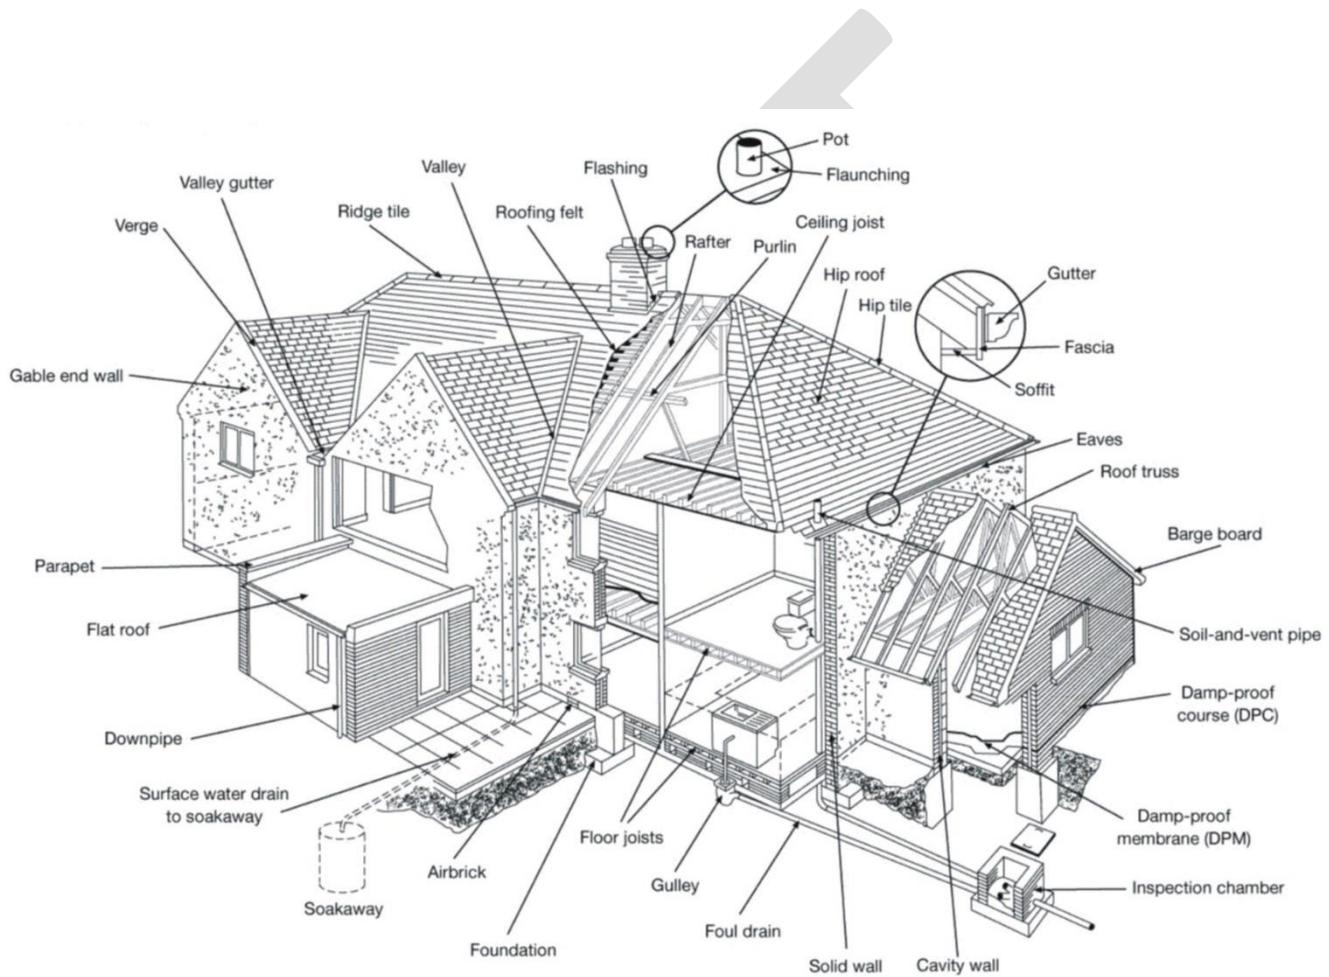
# Typical house diagram

This diagram illustrates where you may find some of the building elements referred to in the report.
