LEVEL 2

Your survey report

9th March 2021

24th March 2021

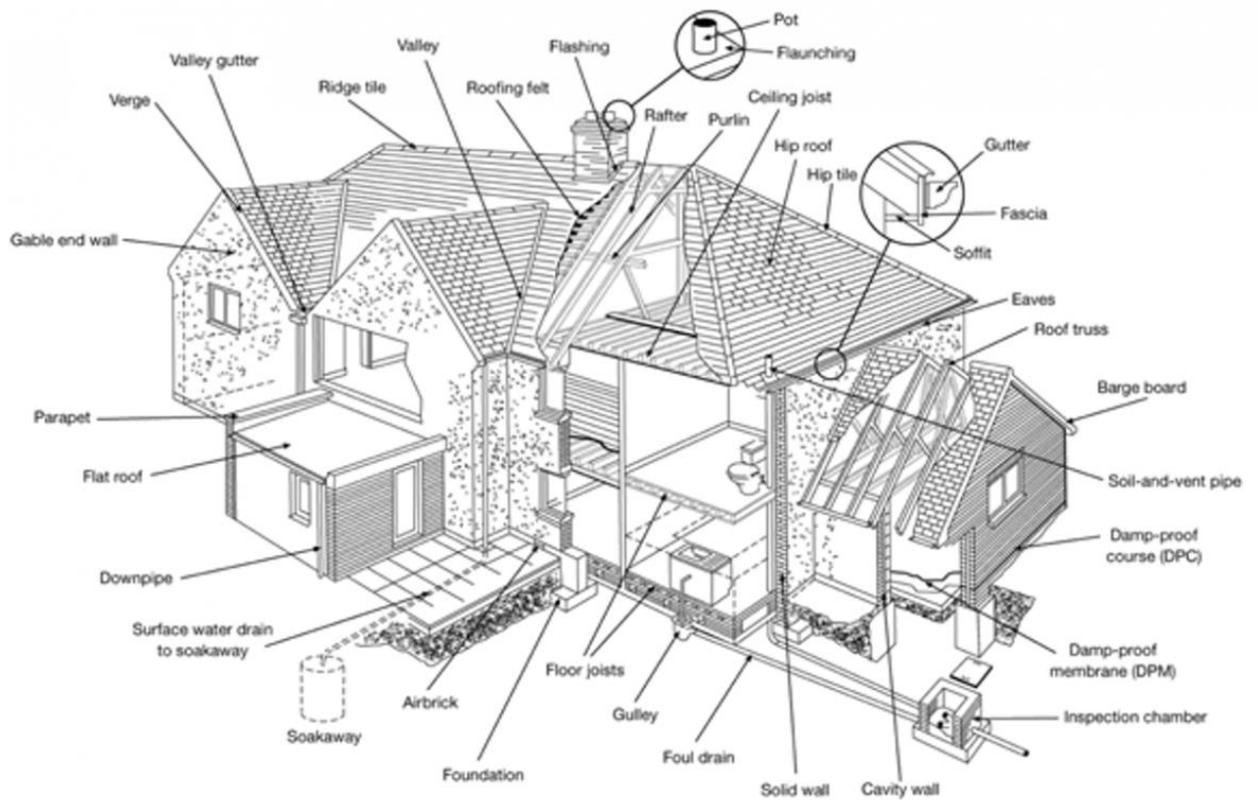
M Typical house diagram

This diagram illustrates where you may find some of the building elements referred to in the report.
